AIRCRAFT ACCIDENT REPORT

**Piper Aztec, PA-23-250 – Registration – N27FT
at Sparendam, East Coast Demerara, Guyana**

April 13, 2013

REPORT # GCAA: 2/5/1/78

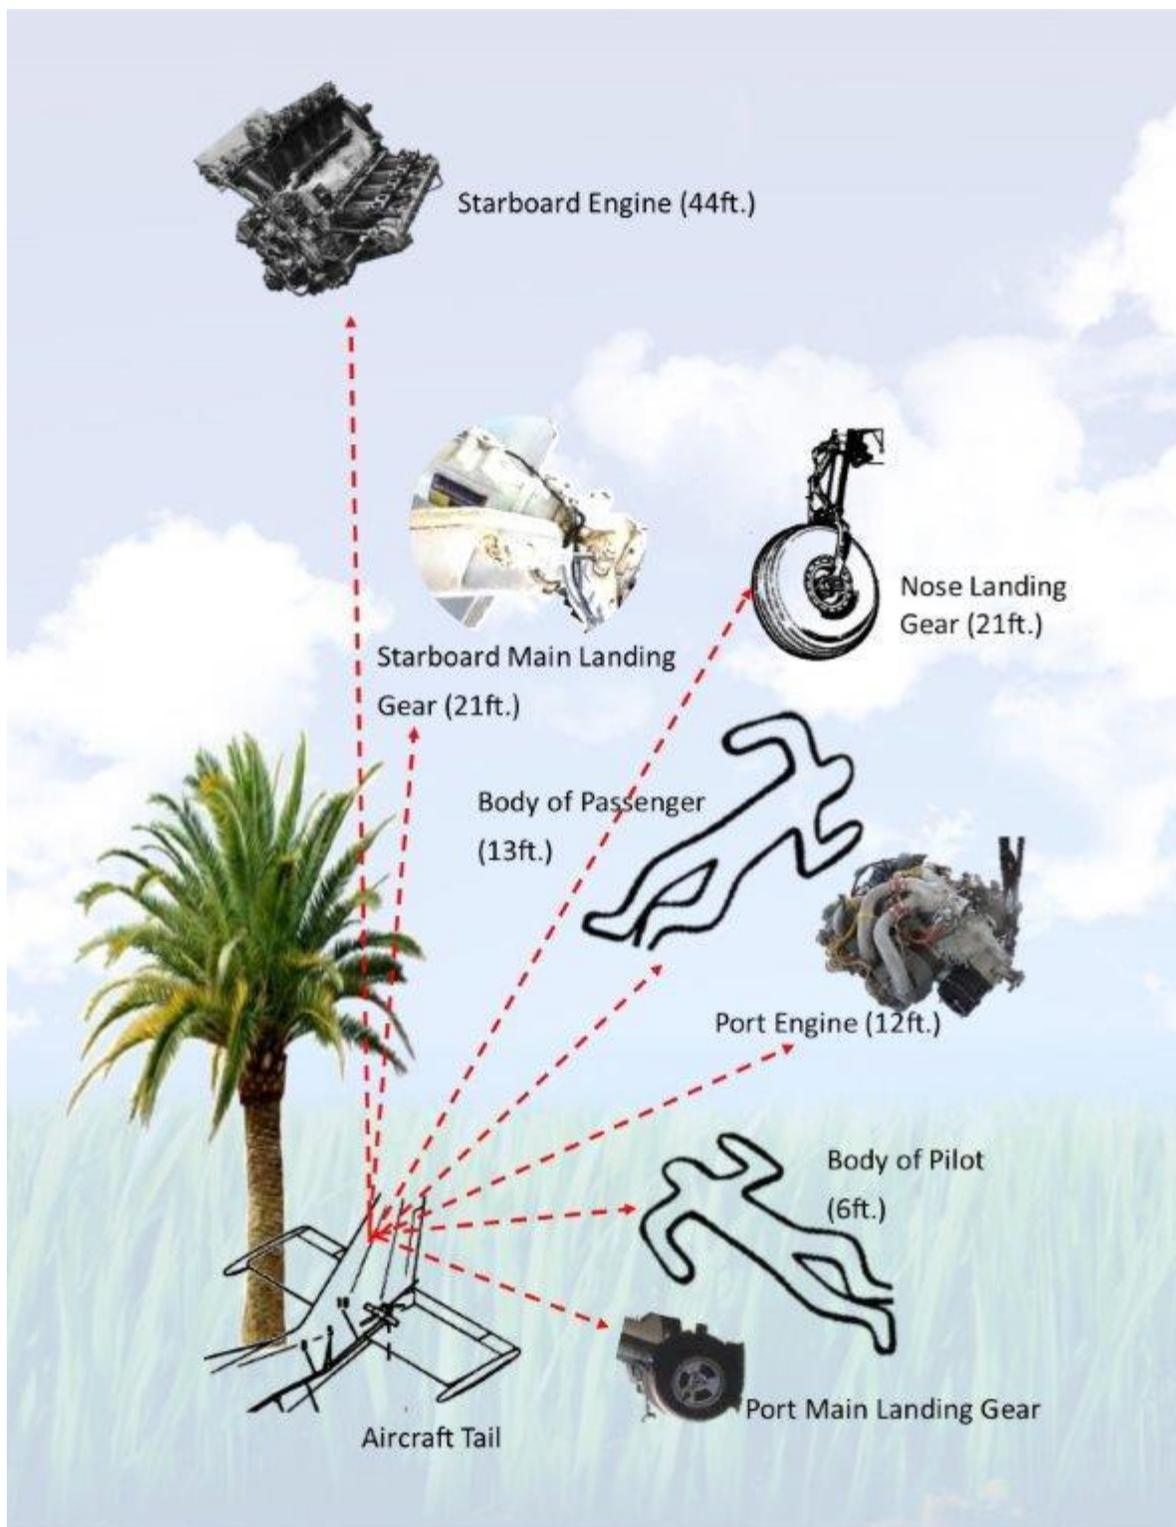
Diagram of Wreckage Site

The tail of the aircraft, which was easily identifiable, was used as a reference point from which to measure the positions of the other identifiable parts of the aircraft, and the bodies of the pilot and the passenger. Measurements taken from the tail tie down were as follows:

1. Port main landing gear – 6ft
2. Port engine – 12ft
3. Starboard main landing gear 21ft
4. Starboard engine – 44ft
5. Nose landing gear – 21ft
6. Body of Survey Technician – 13ft
7. Body of pilot – 6ft.

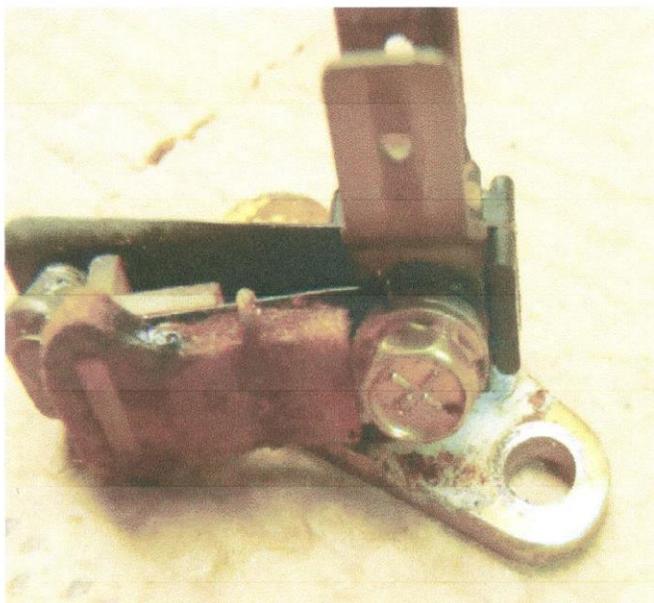
The points cover was removed and internal components examined. Grease-like fragments were present within the case. The metal mounting brackets of the points exhibited corrosion in multiple locations. The electrical resistance across the point contacts was measured with an ohmmeter. In both states the contacts exhibited an open circuit condition, with a resistance of 3.16 Ohms measured with the points closed and 15.6 Ohms when they were open.

The point assembly was removed, disassembled and examined. Corrosion was present on the mounting bracket and the point contacts exhibited shiny-grey discoloration.

Picture No.1 - Corrosion on Points Assembly Bracket – Right Magneto

The discovery of grease-like fragments within the points case and the rusted condition of the metal mounting bracket indicate that maintenance of the magnetos were most likely not being done at the stipulated intervals as required. If routine maintenance is not done, the performance of the magneto deteriorates significantly. This may result in hard starts, and general deterioration of engine efficiency.
