GAAIU

Name of Operator:	Air Services Limited
Aircraft Manufacturer:	Thrush Aircraft Inc. Georgia, USA
Aircraft Model:	S2R-T34
Nationality and Registration Marks:	8R-AAG
Place of Accident/Region:	Bath Settlement Airstrip(SYBS) Region5, Guyana – 06 22 34.27N 057 36 25.10W
Date of Accident:	30 th July 2016
Time of Accident:	12:23hrs UTC

Incident No. GAAIU: 3/1/11

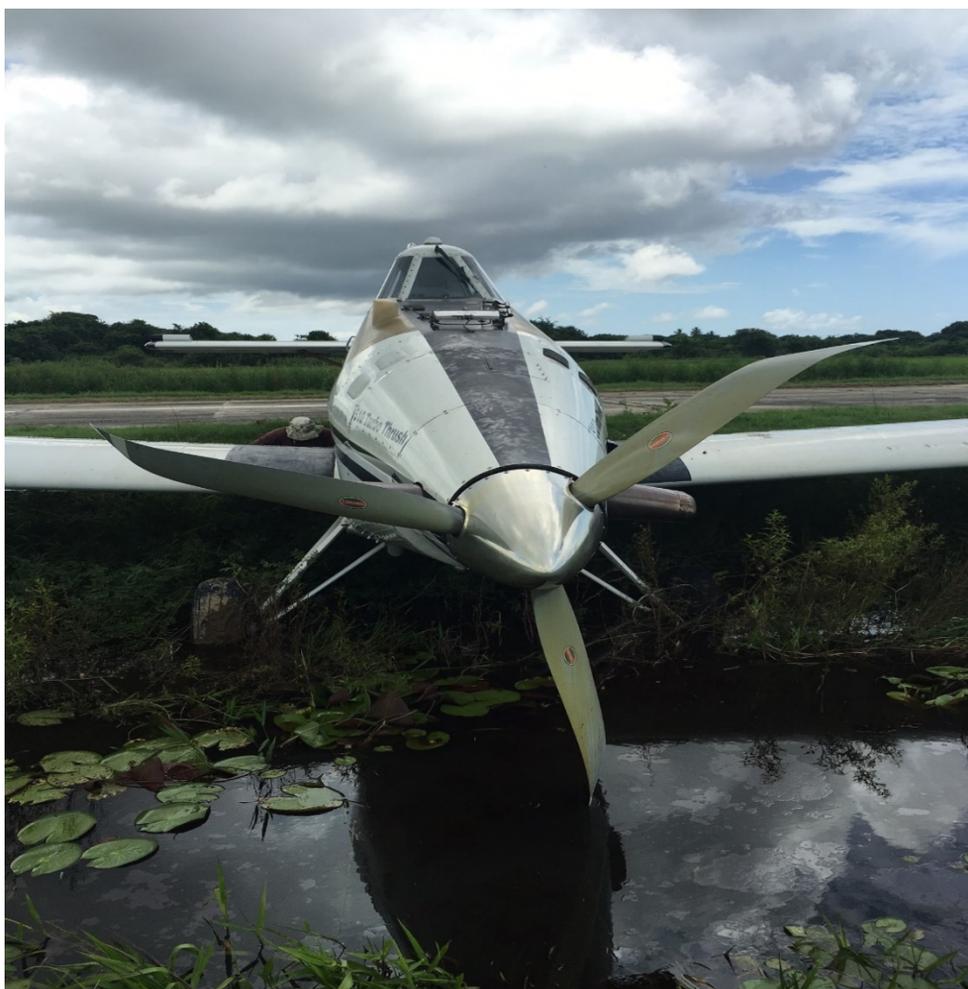
The aircraft suffered a prop-strike and the three blades of the propeller were twisted inwards at the tip. The nose of the aircraft was badly damaged.

During the landing roll, the aircraft veered right, off the runway and stopped 253ft from the end of the concrete portion of the runway, and at the edge of the trench on the right of the runway. The tail wheel was 3ft off the runway and the engine and propeller were over the water. The tips of the propeller were twisted and the right wing tip had mud.

Picture showing final position of aircraft and damage to propellers

The narrowness of the runway, along with the poor condition of the strip and the presence of the trenches along both sides of the strip, contributed to the damage sustained by the aircraft.

1. Plans to upgrade the airstrip should be expedited.
