Name of Operator:	Air Services Limited
Aircraft Manufacturer:	Cessna Aircraft Company
Aircraft Model:	U206E
Nationality and Registration Marks:	8R-GMA
Place of Accident/Region:	Bath Settlement Airstrip/Region#5, Guyana – 06 22 34.27N 057 36 25.10W
Date of Accident:	20 th June 2016
Time of Accident:	21:45hrs UTC

REPORT NO. GAAIU:3/1/9

Synopsis:

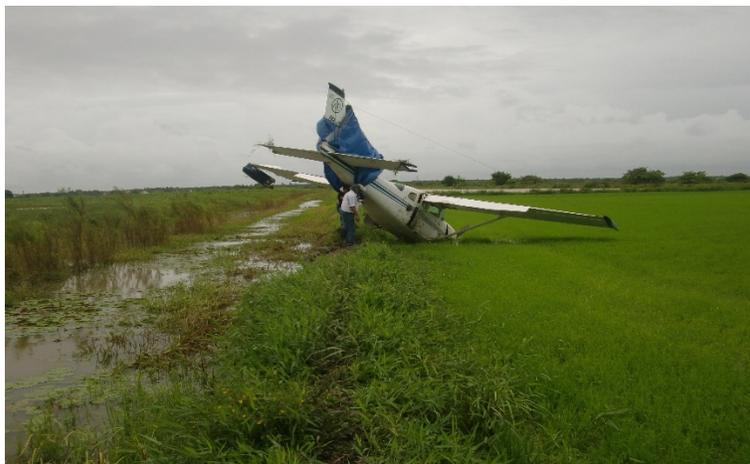
Tracks in the overgrown grass indicated that both the starboard and port main wheels exited the right shoulder of runway 08. The starboard wheel exited the runway first and its track was measured at an angle of 14.4° and 1,100ft from the beginning of the runway. The track of the port main wheel indicated that it contacted the grass off the runway after the starboard main wheel. There was no indication of a nose wheel track on the grass. The aircraft crossed a trench and a mud dam and came to rest, partially in the flooded rice field. The nose wheel, one blade of the propeller and the starboard main wheel were submerged in the rice field, while the port main wheel rested on the dam.

Picture No. 1: Showing final position of Aircraft

The port wing leading edge, which had made contact with the dam, was dented inwards. The port wing tip speed fairing was hanging onto the wing tip. The port flap inner trailing edge was bent upwards against the fuselage for two inches.

Two blades of the propeller were visible and displayed signs of distortion consistent with being powered at the time of impact.

The tail tie-down ring was bent against the empennage.

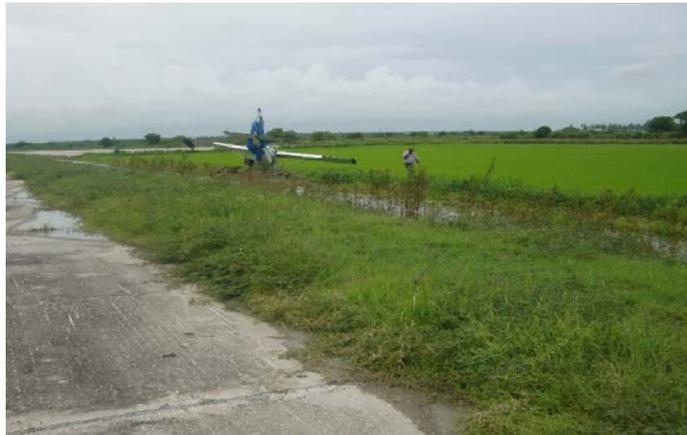
Picture No.2: Showing another view of the aircraft off the edge of the airstrip and the trench which the aircraft crossed before stopping in the rice field
