## TITLE

Name of Operator:	Air Services Limited
Aircraft Manufacturer:	Thrush Aircraft Inc. Georgia, USA
Aircraft Model:	S2R-T34
Nationality and Registration Marks:	8R-AAG
Place of Accident/Region:	MARDS Airstrip (SYMA) Region 5, Guyana – 06 27 53.47 N 057 45 29.68W
Date of Accident:	9 <sup>th</sup> August 2018
Time of Accident:	14:58hrs

### Accident No. GAAIU: 3/1/20

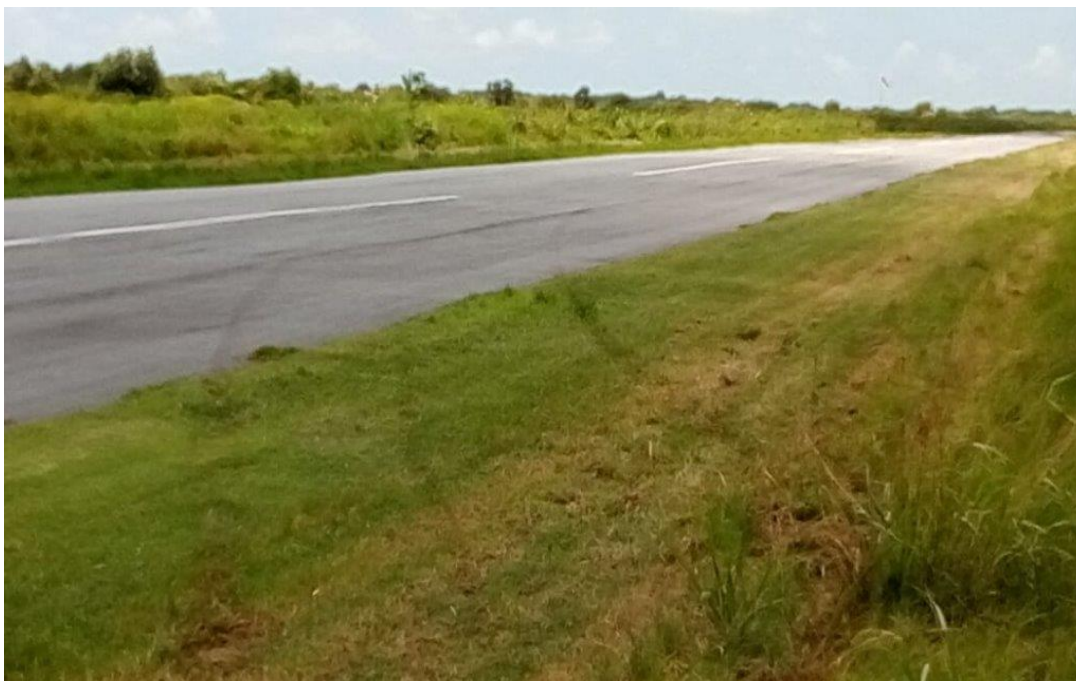
The photograph below was sent to the Air Safety Investigator. He advised that the locking mechanism should be checked for functionality and the right brake should be checked to determine its effectiveness. He advised that evidence from the photo indicates that the aircraft was heavily side loaded when it departed the runway, meaning it was traveling at a relatively high rate of speed in a specific direction and the longitudinal axis of the aircraft was not parallel with the direction of travel. He also noted that evidence indicates that the tail-wheel was on the ground prior to departing the runway, but because it was castering, it did not leave a streak mark on the hard surface. Further, the angle in which the aircraft departed the runway is too great for the tail-wheel to caster if it were in fact locked. If the pilot inadvertently unlocked the tail-wheel during the landing (this is done by pushing the control stick full forward), the aircraft would be very difficult to control until such time when the tail-wheel was straightened and the lock mechanism was able to engage. Typically, if the tail-wheel was unlocked inadvertently and subsequently locked once it was aligned again, there is a high probability of damage to the locking pin which will be slightly bent.

*Picture showing track marks of aircraft undercarriage – left turn off runway*
