AIRCRAFT ACCIDENT REPORT
Caribbean Airlines/Fly Jamaica ground collision.

FINAL REPORT

GROUND COLLISION BETWEEN CARIBBEAN AIRLINES BOEING 737-8HO, 9Y-SXM AND FLY JAMAICA BOEING 767-319ER, N767WA AT CHEDDI JAGAN INTERNATIONAL AIRPORT, GEORGETOWN, GUYANA ON 29th NOVEMBER 2016

REPORT No. GAAIU 3/1/12

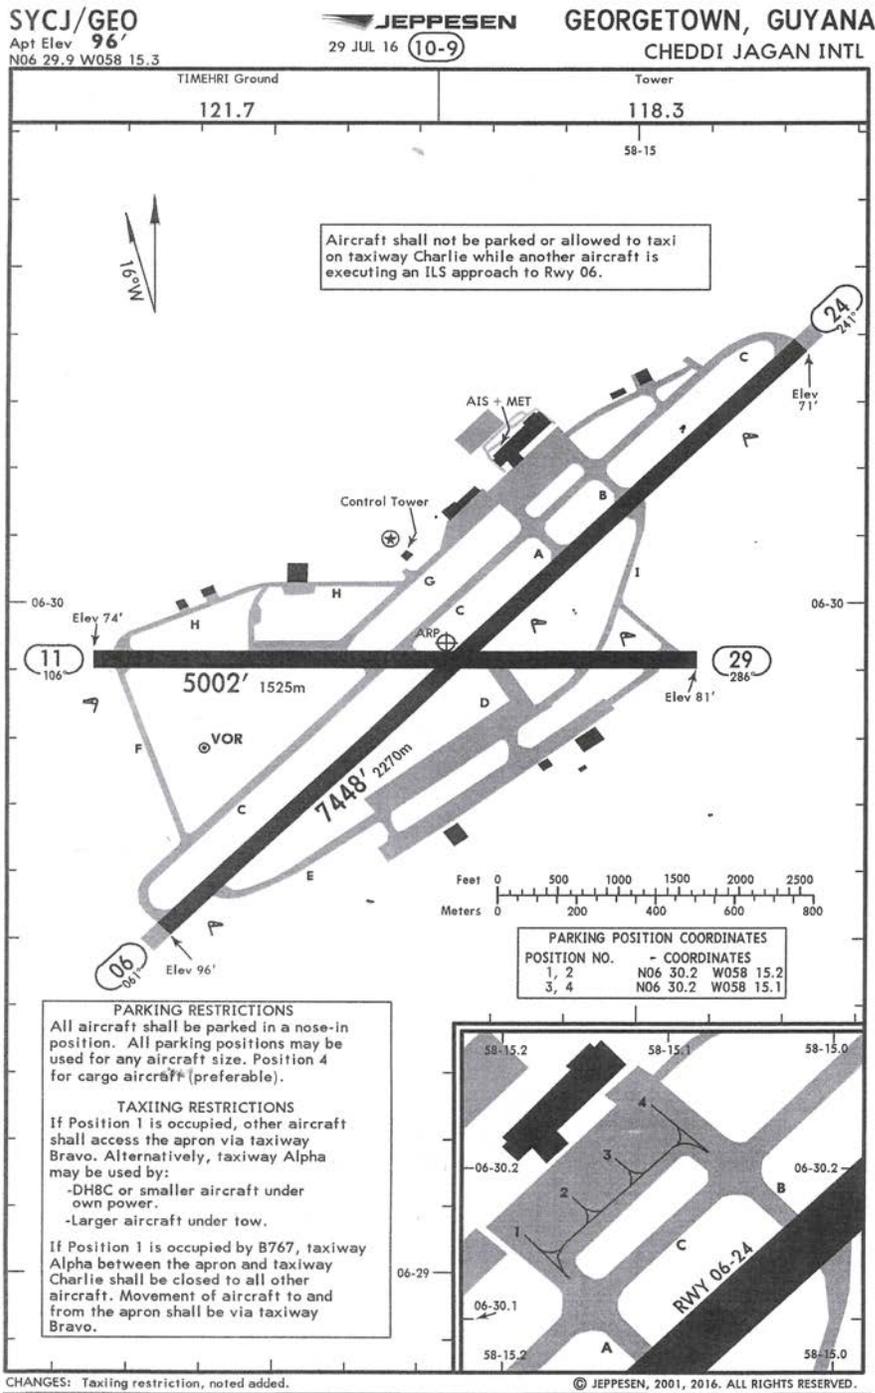
Figure 3. Jeppesen chart, P. 10-9, Georgetown, Guyana.

2. The statement “*Large aircraft should not taxi behind a parked B767*”, showed that CJIA had serious concerns about a ground collision, but dealt with it inadequately.
3. The Guyana AIP and the Jeppesen Parking Restrictions both stated, “All parking positions may be used for aircraft of any size”, which was obviously inadvisable and likely to cause ground collisions. Also, it contradicted the Airside Directive.
4. The Guyana AIP and the Jeppesen Taxiing Restrictions addressed only circumstances existing when Parking Position 1 was occupied.

Thus, these three sets of instructions were inadequate to prevent, and were more likely to cause, ground collisions, and, in any event, it was unlikely that any instructions other than the Jeppesen ones would be available to an incoming flight crew.

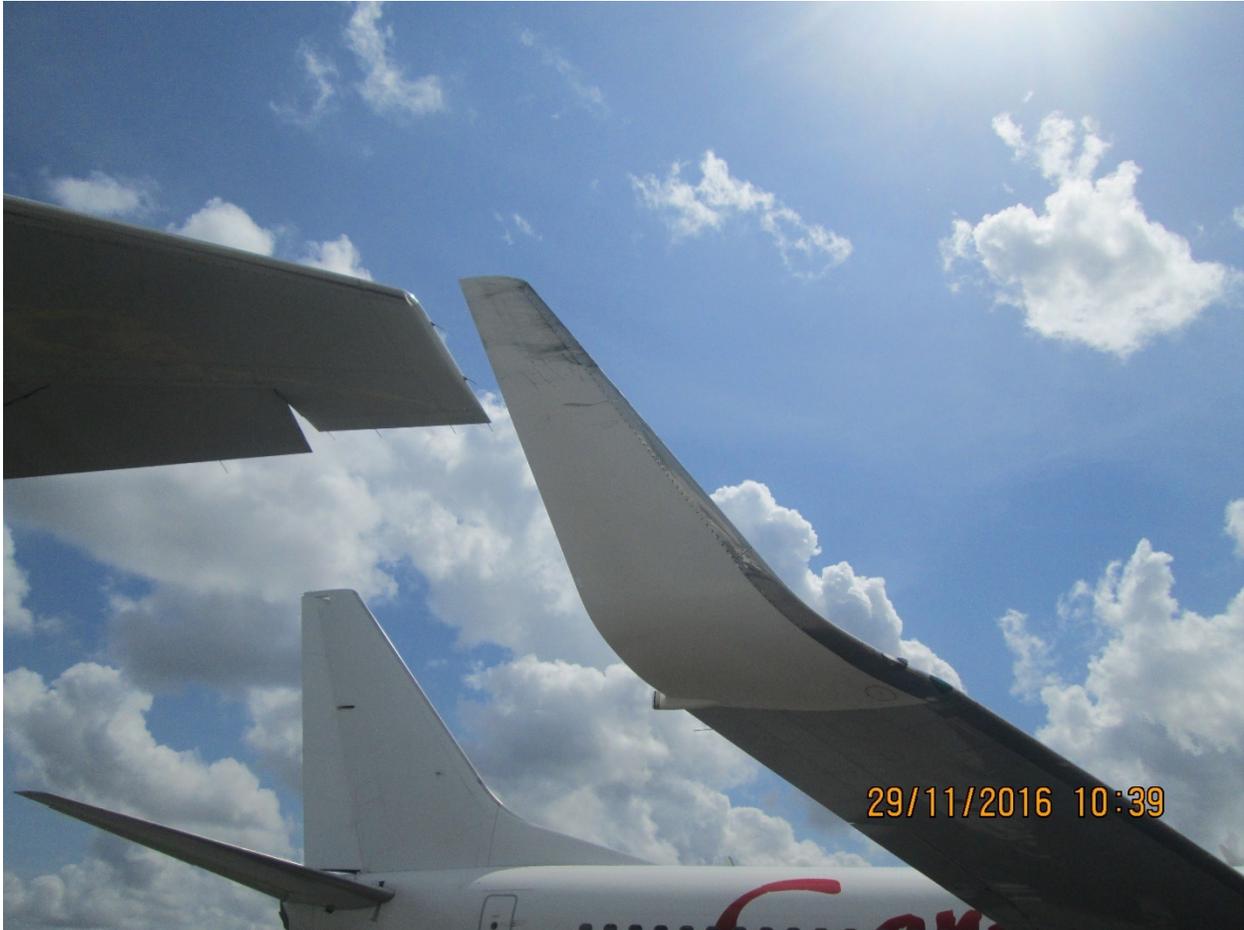
The right winglet of the B737 was damaged by contact with the B767’s elevators and tail cone, to the extent that it had to be replaced.

2. Winglet of CAL aircraft.

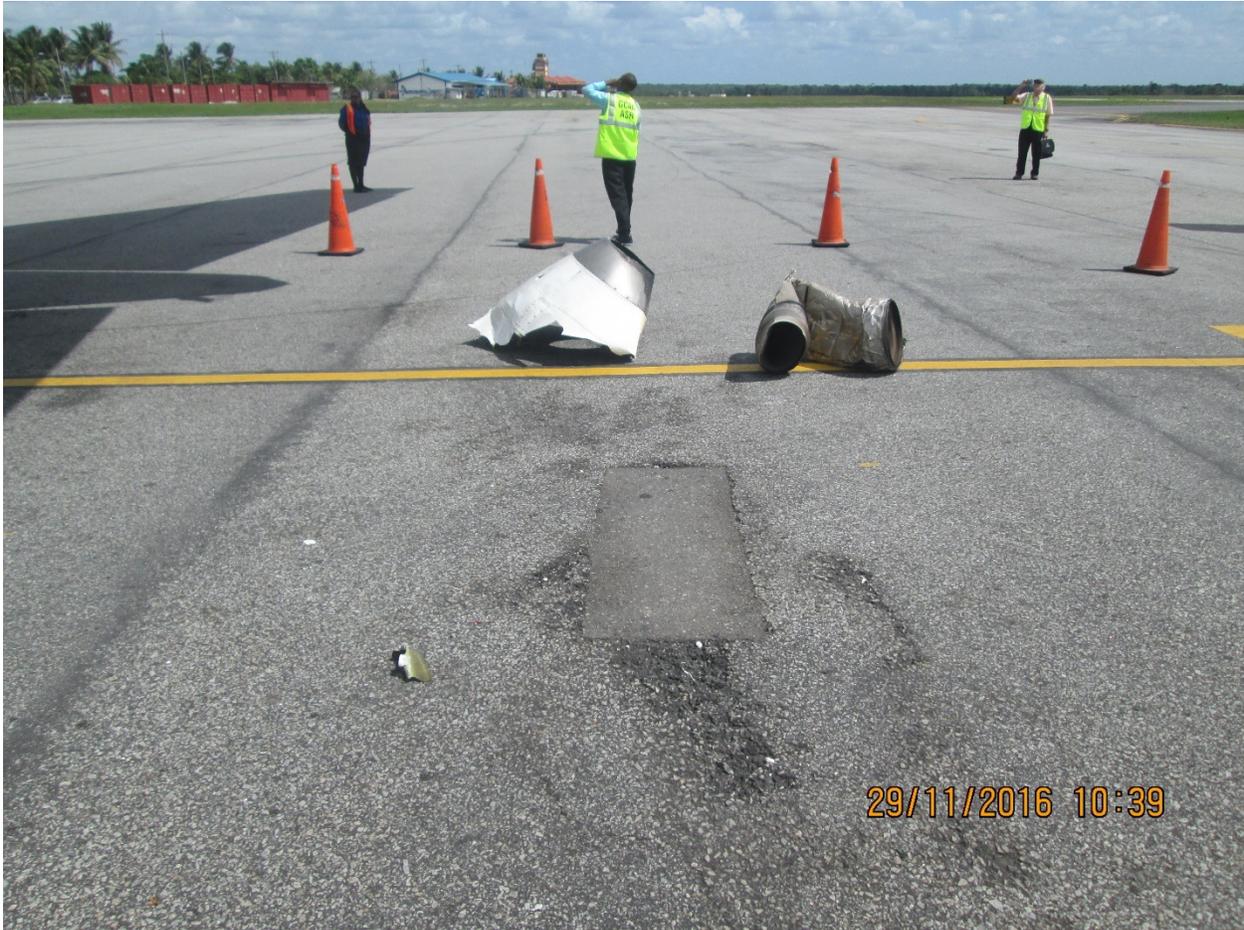
The left and right elevators of the B767 were damaged and the tail cone was sheared off by the right winglet of the B737 (see Section 6: Photographs). The B767 has an Auxiliary Power Unit (APU), a small gas turbine-powered generator, in the tail of the aircraft, and this was running at the time of the accident. Its exhaust pipe in the tail cone was torn off, but the APU itself was not damaged.

3. Damaged parts of B767 on ground.

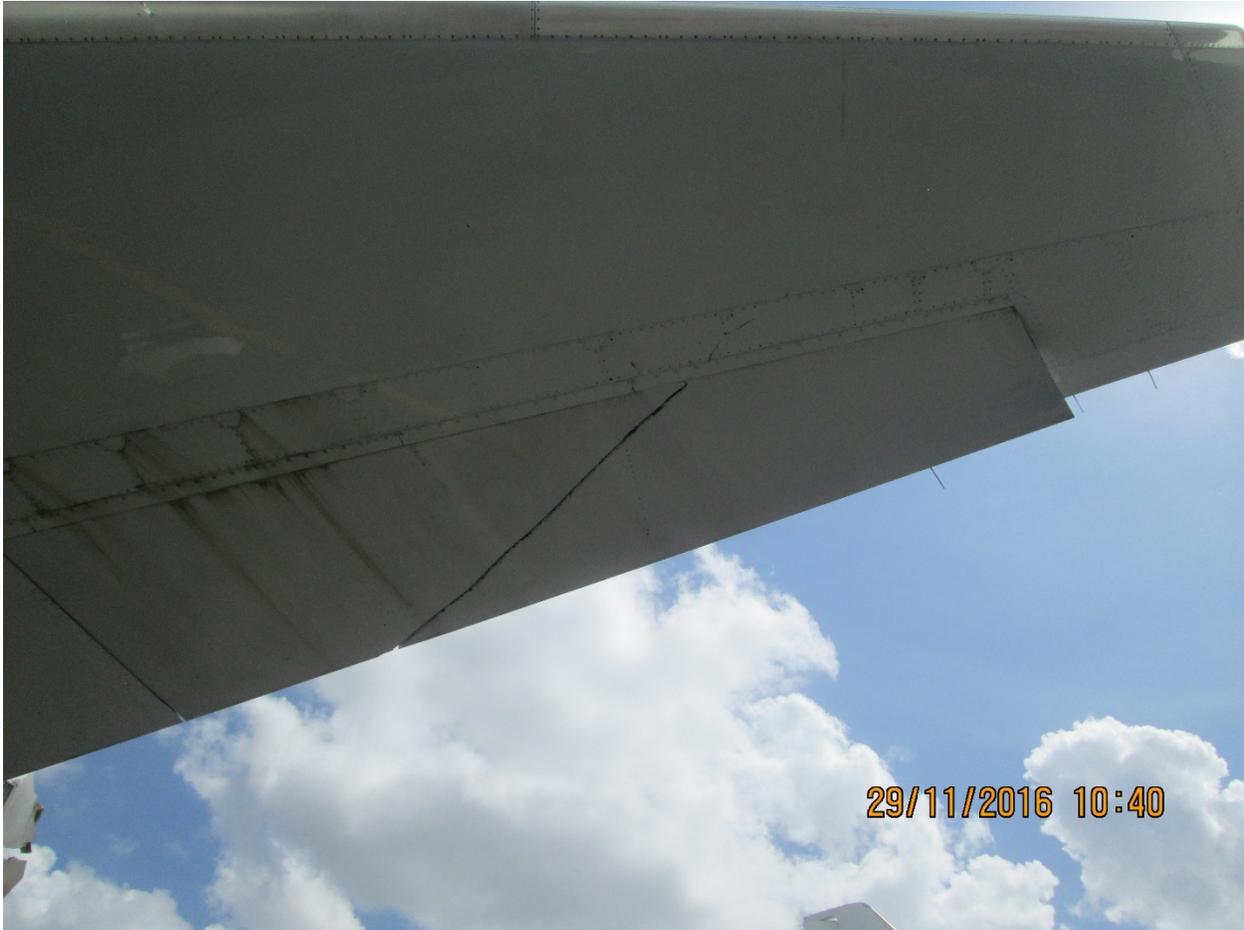
At 11:36hrs, as the B737 taxied behind the B767, the right “winglet” of the B737, a vertical section at the tip of the wing, 8 feet tall, nicked the trailing edge of the B767’s right elevator, cut off the tail cone and sliced through the left elevator (see Section 6: Photographs).

4. Damage to B767 left elevator.

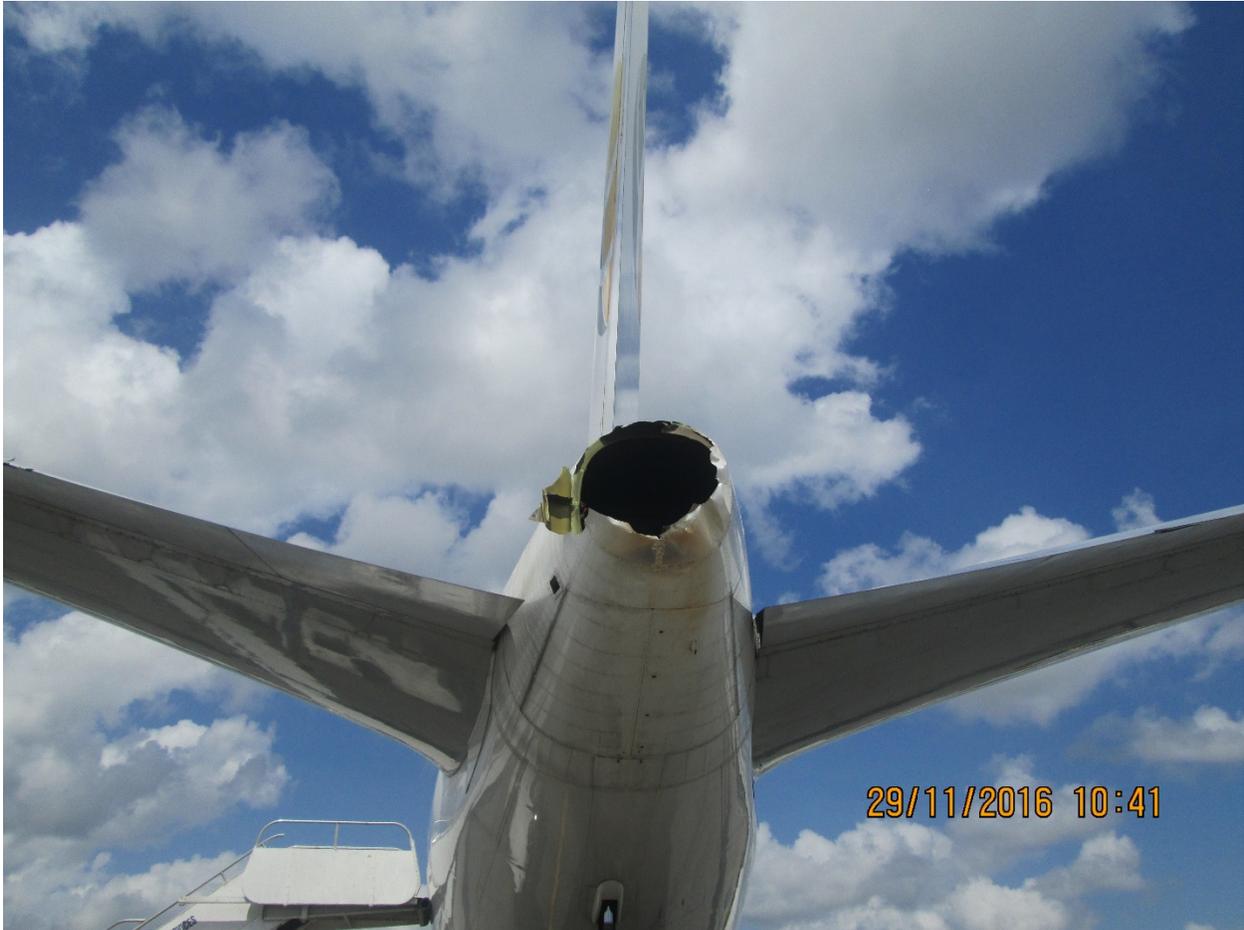
5. Damage to B767 tail cone.

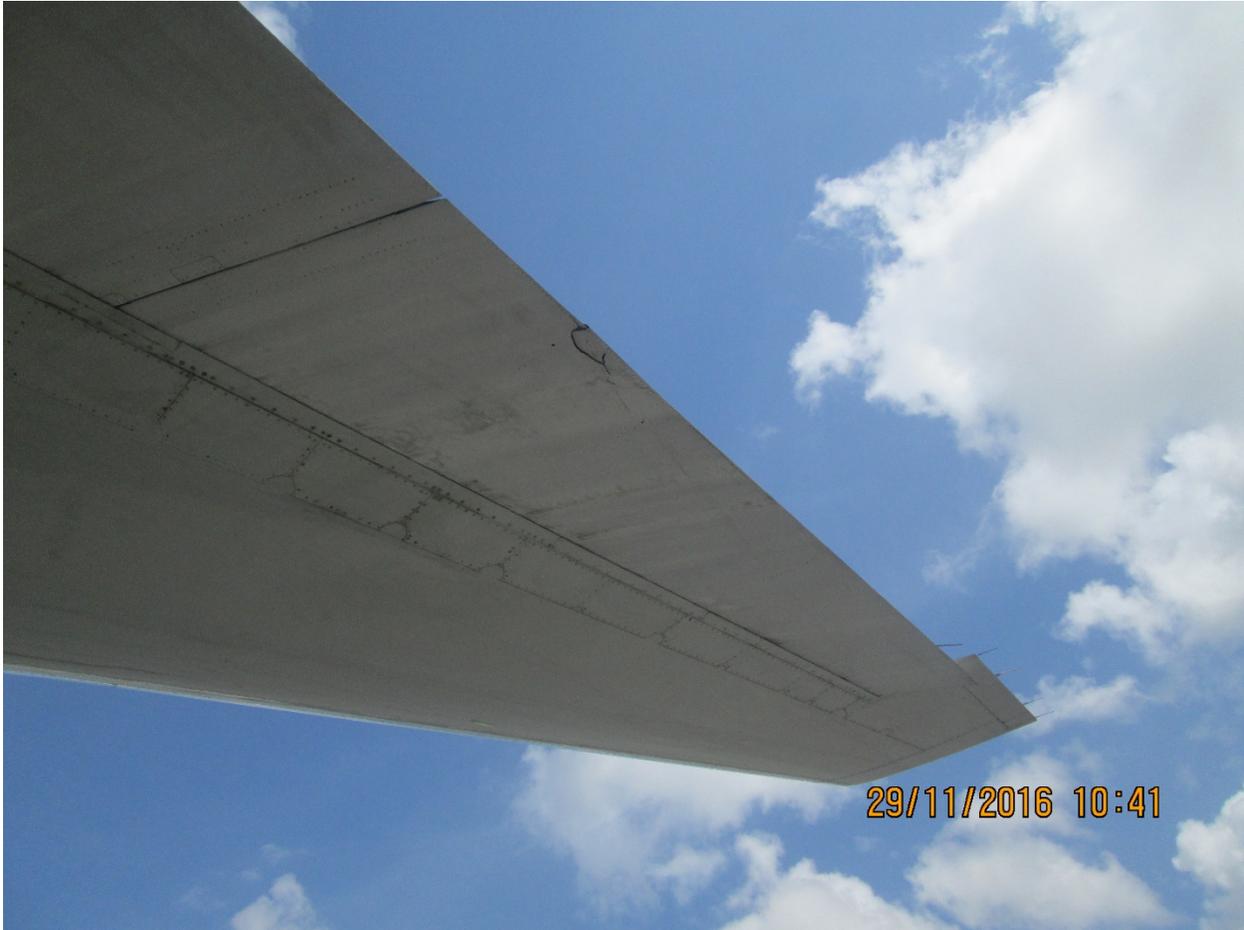
6. Damage to B767 right elevator.

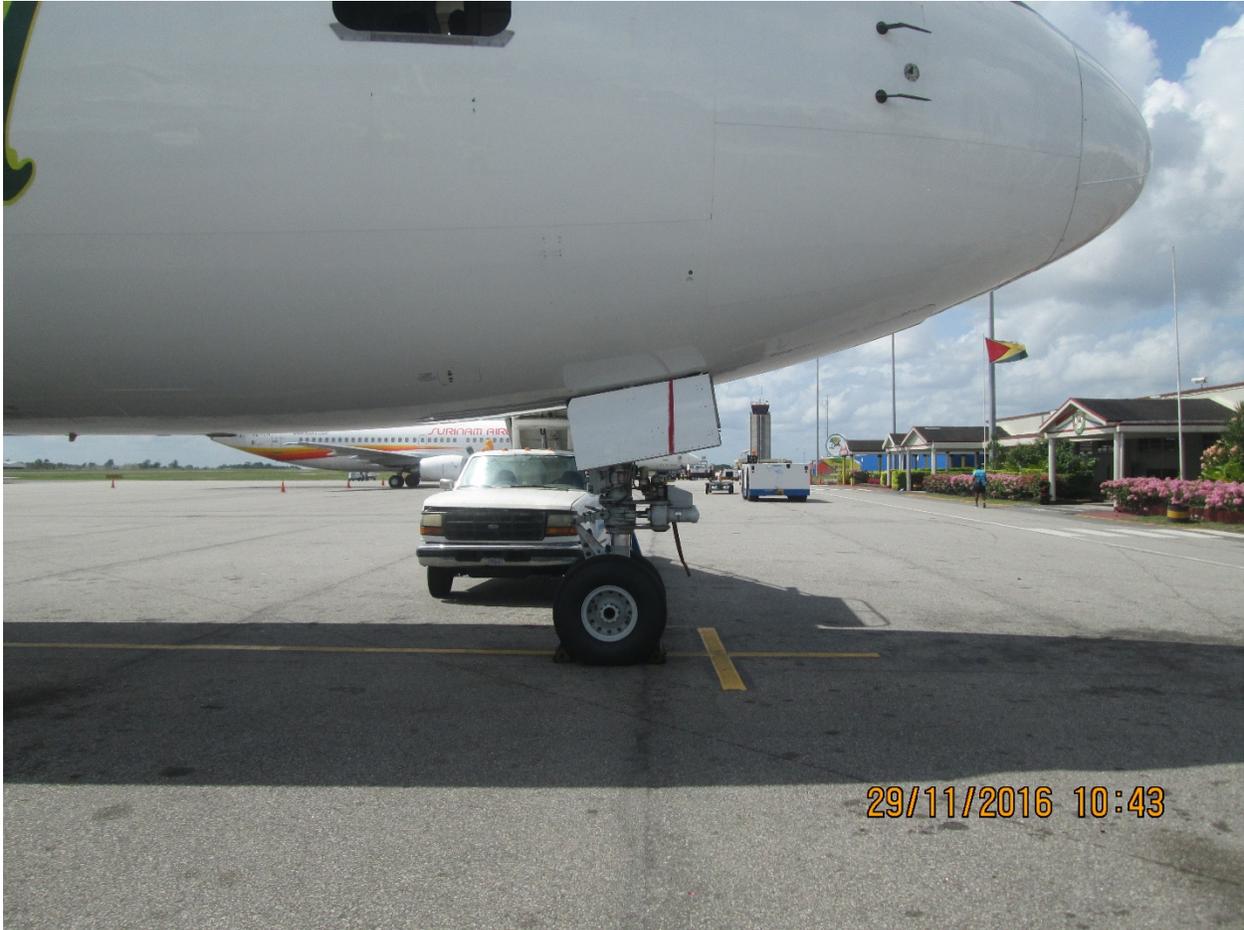
As the flight crew could not see the nose wheel's position from the cockpit, it was the responsibility of the marshaller to ensure the nose wheel was in the correct position. This was not done. This was another example of poor marshalling procedures, and inadequate operational control.

If the B767 had been correctly parked, it is probable that the winglet would still have contacted the tail of the aircraft, and caused damage.

7. Position of B767 nose wheel.

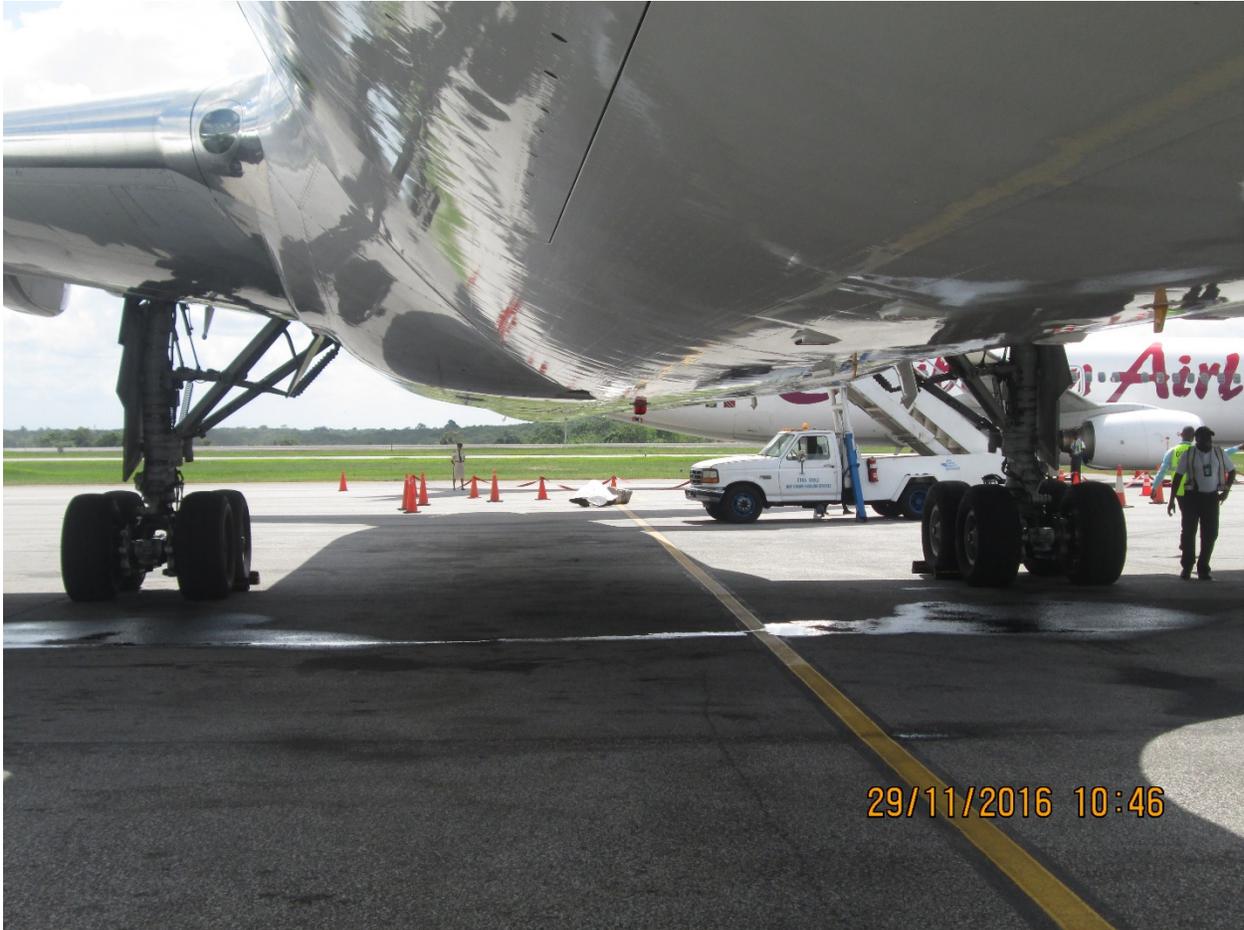
8. Position of B767 main gear.
