AIRCRAFT INCIDENT REPORT

Piper Cherokee PA32

Registration – N87619

REPORT # GCAA: 2/5/1/74

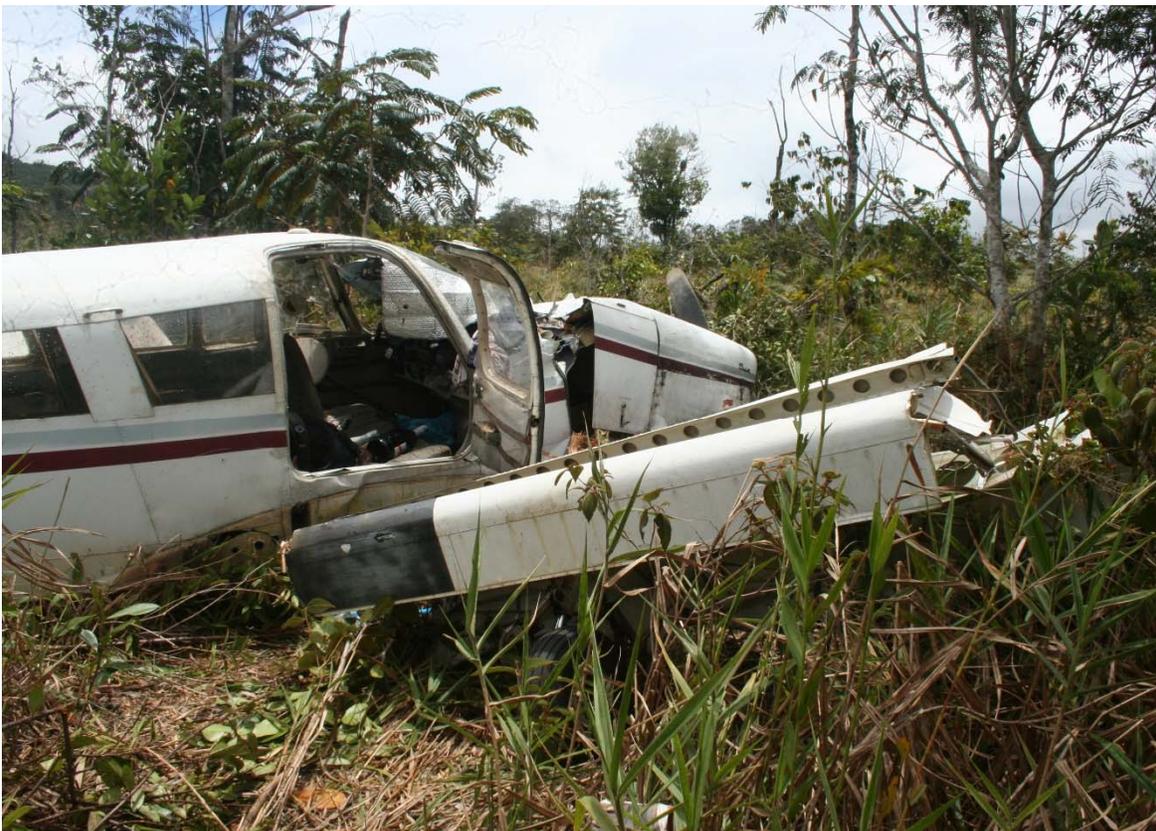
1. Picture of the Wreckage

The impact between the starboard wing and the tree caused the entire starboard wing to be separated from the fuselage and the right wing tip tank and aileron were sheared from the wing. The port wing tip fairing was severed by impact with another tree.

Both main fuel filler ports were separated from the main fuel tanks.

The nose wheel separated from the nose gear and was found buried in the ground almost 20ft behind the main starboard wheel.

Both the pilot seat and the right No.1 passenger seat were secured in the seat rails, but the no.1 passenger seat back was broken at the attachment point.

One of the propeller blades had penetrated the ground. The other blade showed signs of impact with trees and the ground.
