# **FINAL REPORT**

## **AIRCRAFT ACCIDENT INVESTIGATION REPORT**

Report / File. No:	-	<b>AAIU: 3/1/33</b>
Registered Owner / Operator	-	<b>RORAIMA AIRWAYS INC</b>
Aircraft Model / Type	-	<b>BN-2A-III-2 TRISLANDER</b>
Nationality	-	<b>GUYANESE</b>
Registration	-	<b>8R-GRE</b>
Place of Accident / Region	-	<b>HAAGS BOSCH SANITARY LANDFILL, EAST BANK DEMERARA, REGION 4, GUYANA COORDINATES: 6.7645° N, 58.1494° W</b>
Aircraft Manufacturer	-	<b>FAIREY BRITTEN-NORMAN</b>
Date of Accident	-	<b>14 AUGUST 2021</b>
Time of Accident	-	<b>15:29 UTC (11:29 GST)</b>

**REPORT / FILE #: GAAIU 3.1.33**

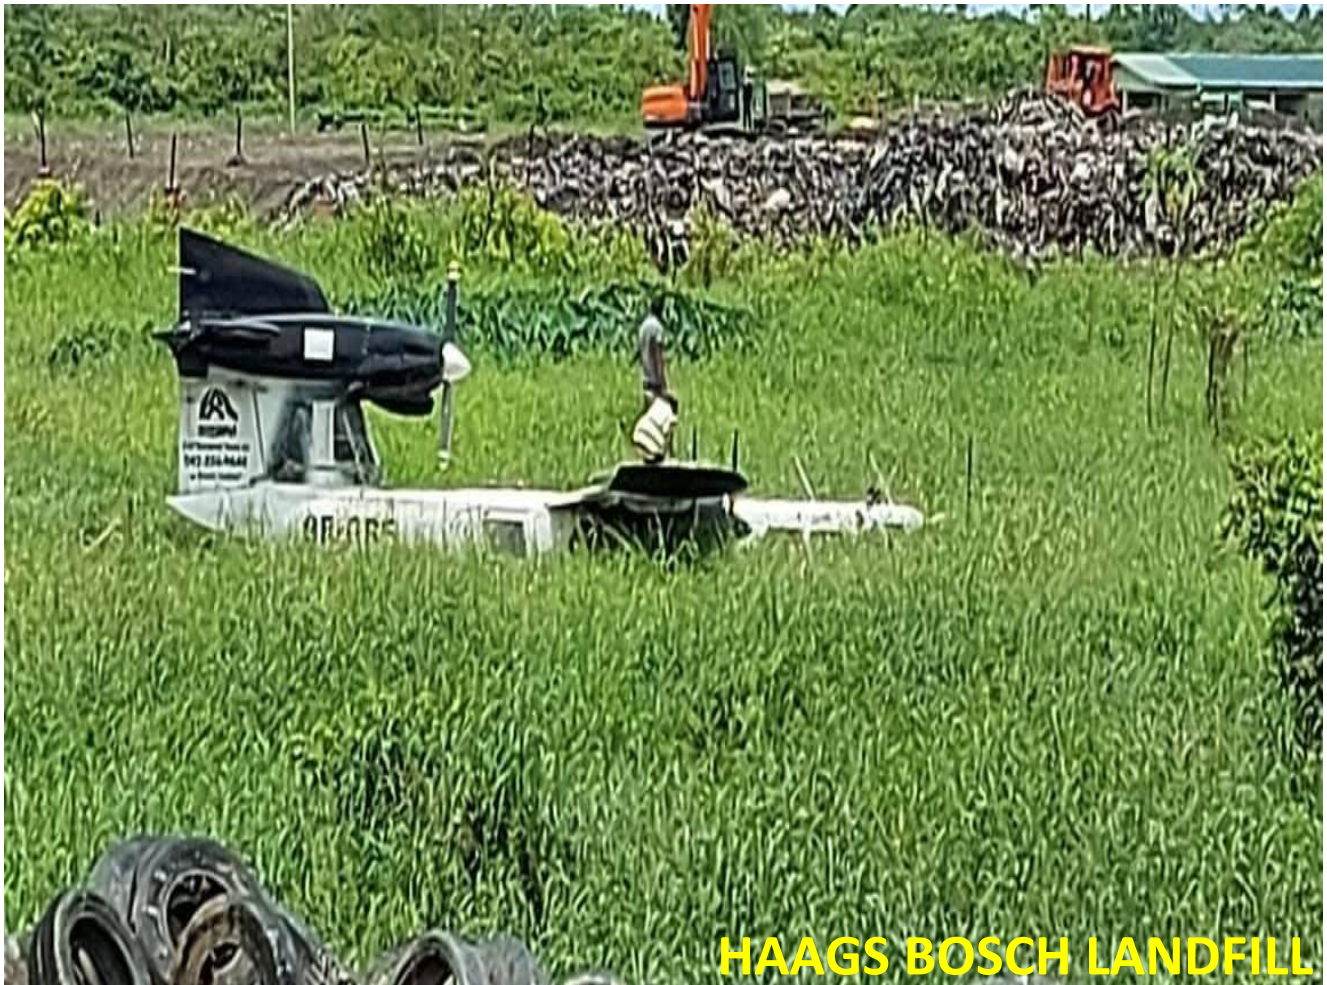
The aircraft was ditched (force landed, Commander's words) into the swampy area of the Haags Bosch Sanitary Landfill in Region 4, Guyana, approximately seven (7) nautical miles from its intended arrival aerodrome SYEC. The aircraft suffered some structural damages to the nose section. The crew had no injuries; however, one (1) passenger (female adult) had a gash over her left eye, the male adult passenger was diagnosed with a bleeding liver at the hospital, and the third passenger (a child under two (2) years old) had no injury.

The Haags Bosch Sanitary Landfill is a controlled area for the disposal of waste material (garbage) by burying it. The area where the aircraft landed had garbage and tall grass and was under water of approximately three (3) feet high.

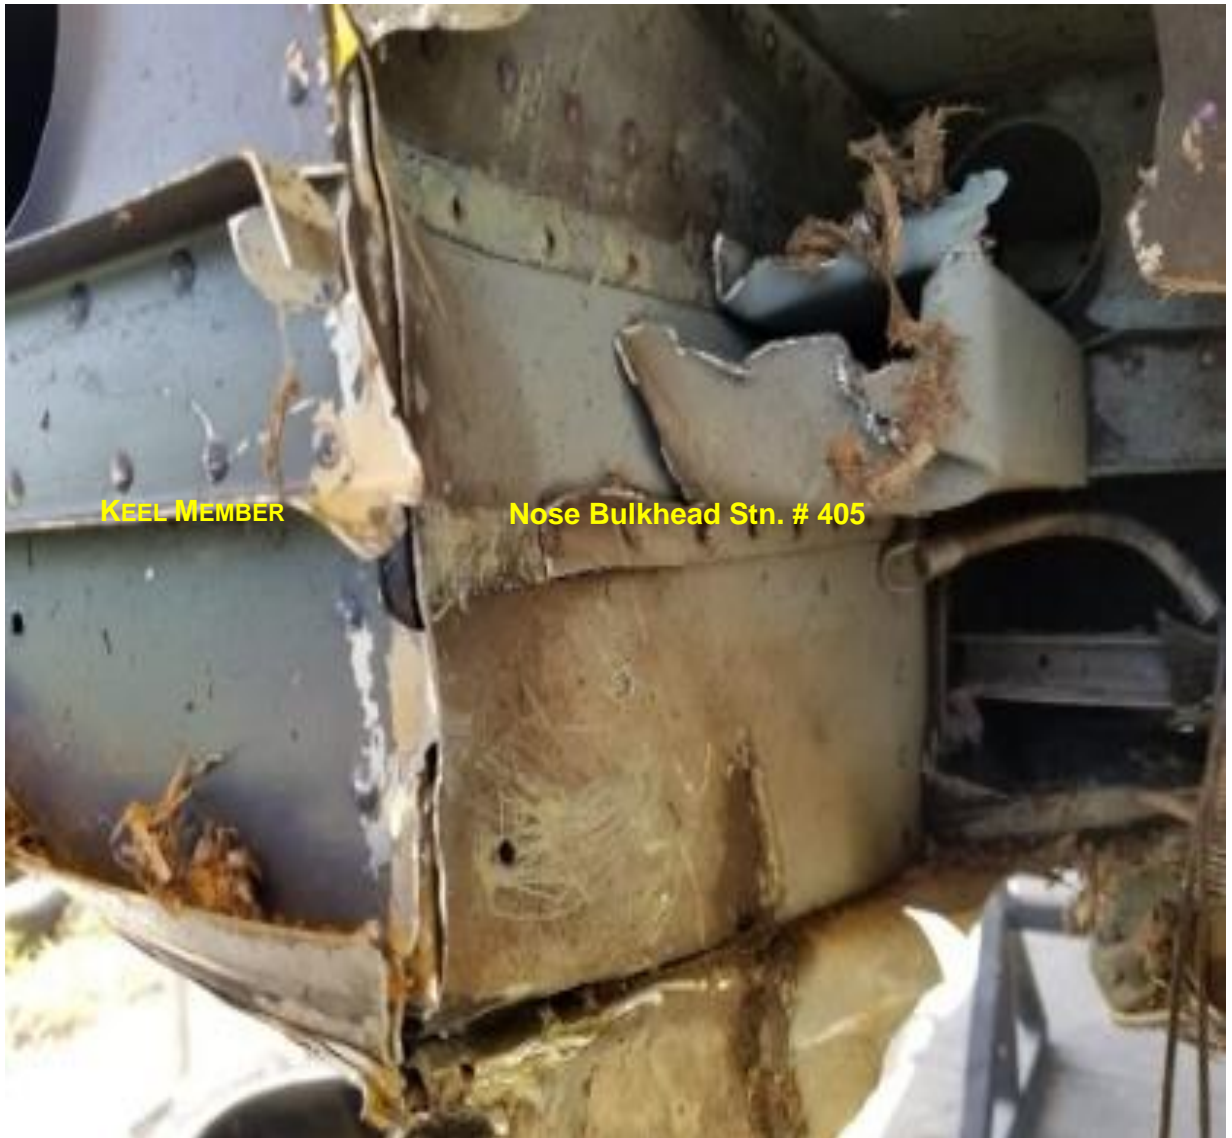
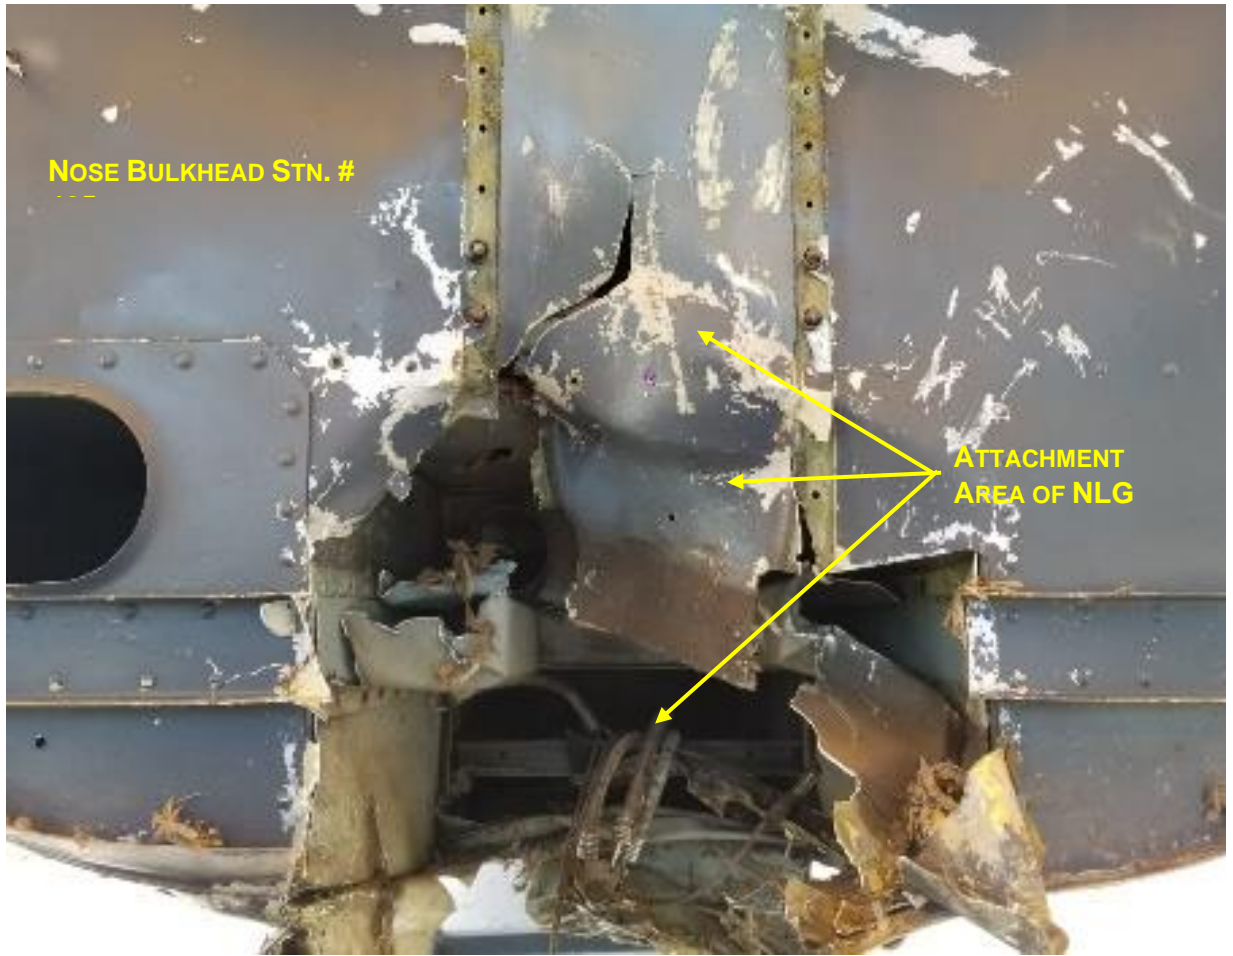
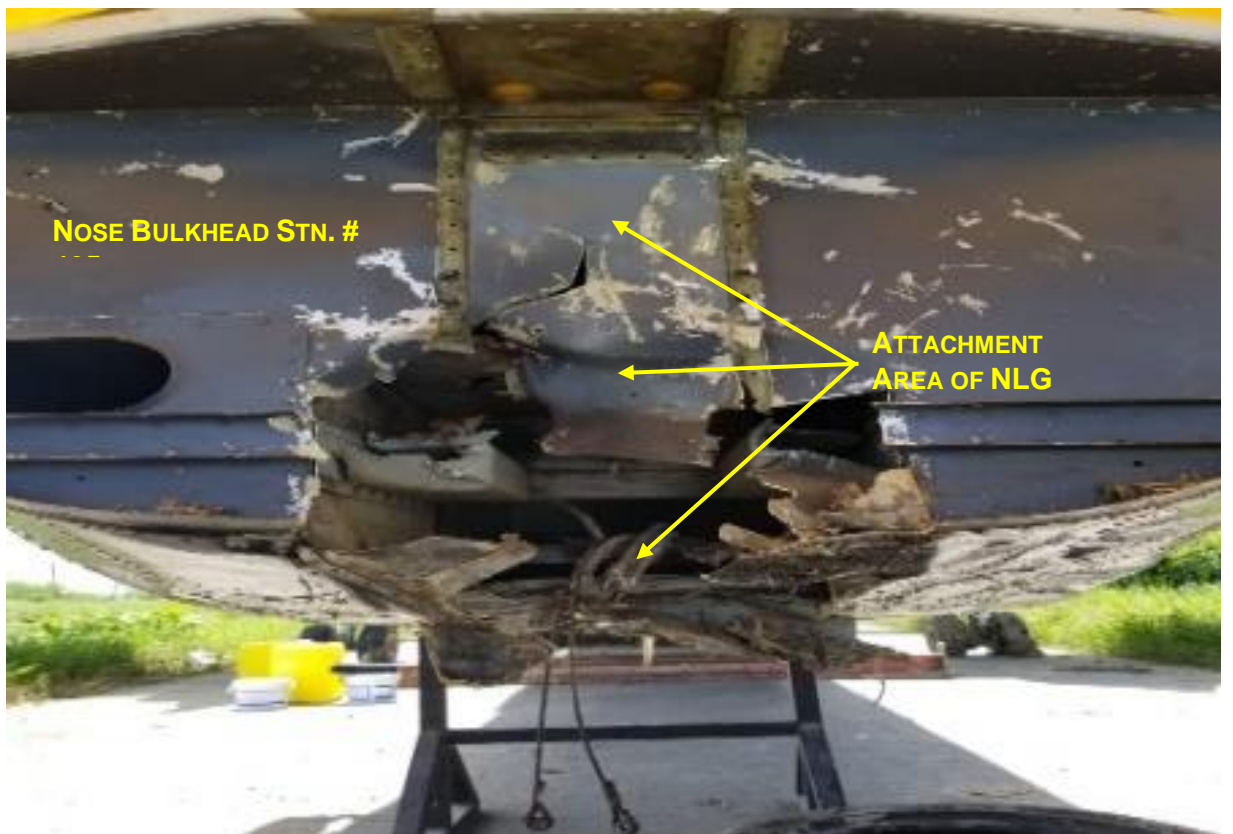
- a. The nose bulkhead at Stn. # 405, attachment area for the NLG, had major structural damages.
- b. The keel members attached to the bulkhead had major structural damages.
- c. The nose cargo bay had structural damages.
- d. The nose section bottom skin had major structural damages.
- e. Heavy landing inspections / checks were carried out and found satisfactory.

**PICTURES BELOW SHOWING NOSE AREA DAMAGES**

The damage to the aircraft was confined to the nose section. The aircraft was removed from the crash site and repositioned to an asphalted road in the vicinity of the crash site. Temporary repairs were done to the nose section and aircraft was flown from the road to RAI Base at SYEC.
