**AIRCRAFT ACCIDENT REPORT**

**Cessna 208B Caravan**

**Registration – 8R-GHS**

**REPORT # GCAA: 2/5/1/73**

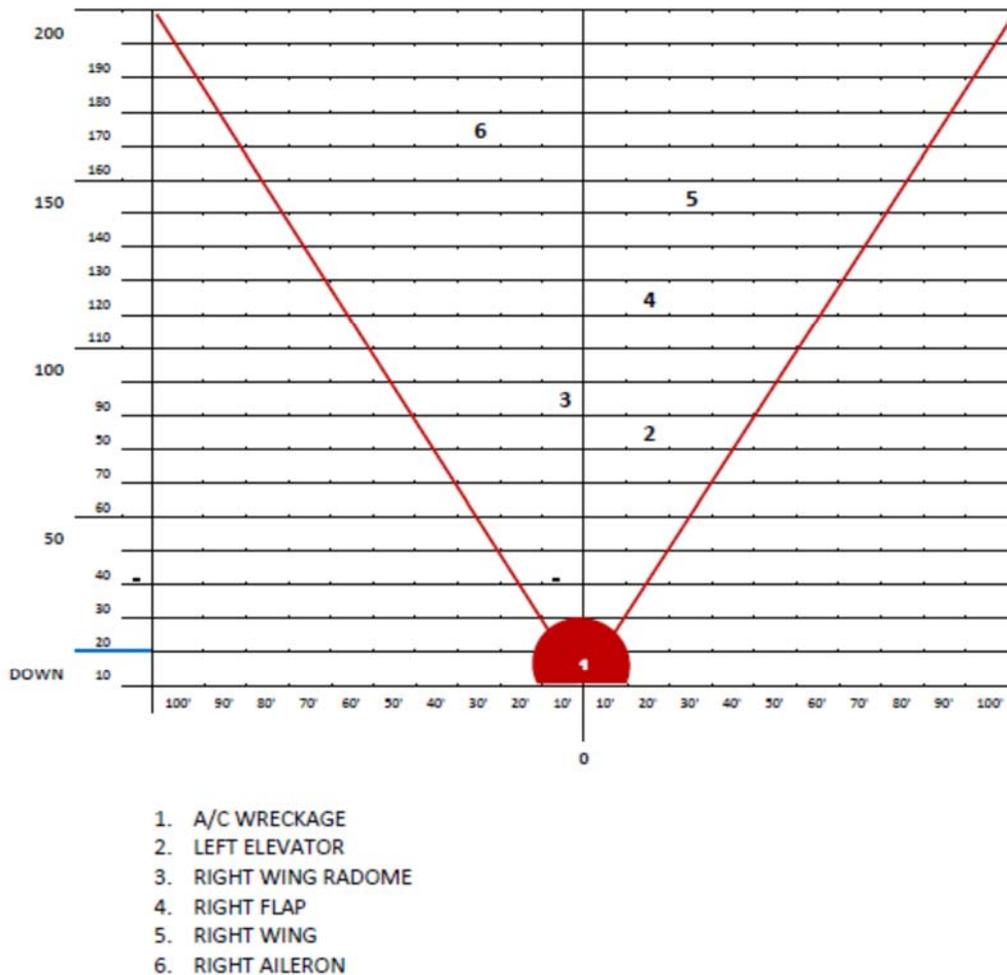
**Diagram:1 – SHOWING SCATTER OF AIRCRAFT WRECKAGE**

The wreckage debris field was found over an area of approximately 180ft from the point of impact. The angle of penetration, from the point of impact to the wreckage, indicated an approximate slope of 30°. Pieces of the aircraft were found between 10° and 30° left of the penetration line and two pieces were found between 5° and 10° to the right.
