| Name of Operator: | Air Services Limited |
|---|---|
| Aircraft Model: | Cessna U206G |
| Nationality and Registration Marks: | 8R-CNK |
| Date of Accident: | 11 th February 2017. |

REPORT No. GAAIU 3/1/13

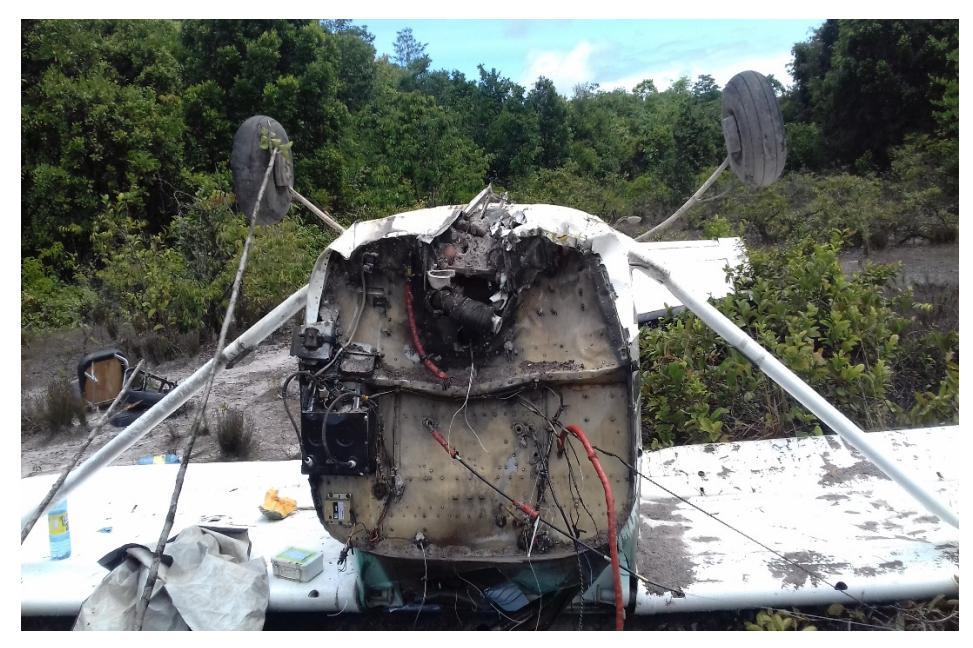
Indentations on the ground show that the nose wheel dug into soft sand at the end of the airstrip. The nose wheel came off the ground and dug into the ground again and became separated from the nose wheel mount.

The aircraft engine made contact with the ground 35ft from the initial point of impact. The nose of the aircraft and the engine dug into the ground and broke away from the rest of the fuselage. The aircraft engine came to rest on the right of the main fuselage, which had flipped over lengthwise, and ended up upside down, facing the direction of takeoff.

Picture #1: The fuselage separated from engine and nose wheel.

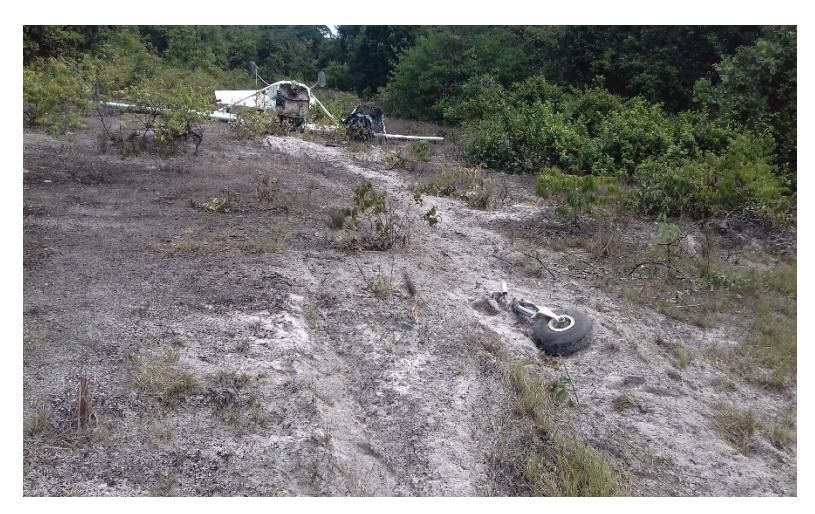
The nose wheel was completely separated from the airframe. The aircraft itself was found upside down. The engine, with propeller attached, had separated from its attachment points on the aircraft firewall. The firewall itself was badly wrinkled, but the battery was

Picture #2: Fuselage with separated engine and nose wheel.

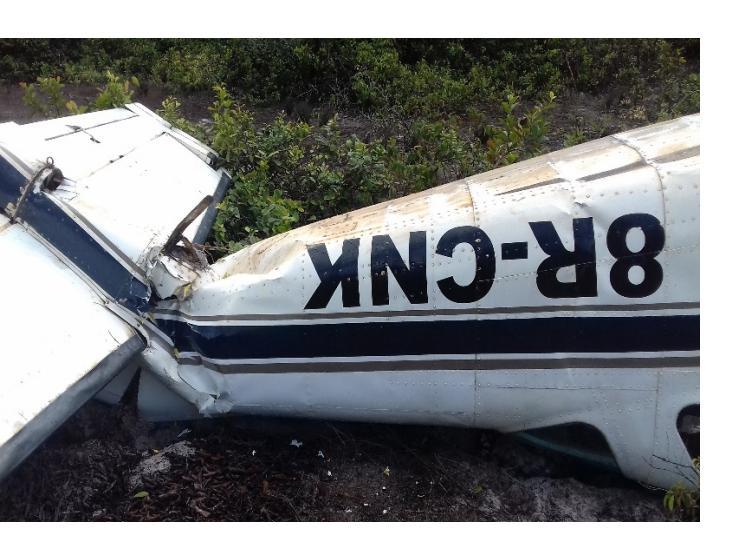
The tail of the aircraft was broken, but not separated from the fuselage. The underside of the right wing was distorted. The flaps on both wings appeared to be set at 5°. There was some up-trim on the elevator trim tab. All engine controls were forward.

Picture #3: Damaged Tail-plane

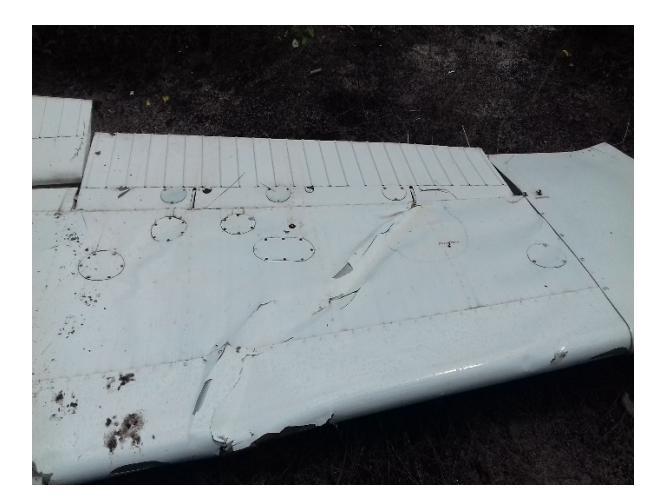
Picture #4: Distortion on starboard wing.
