AIRCRAFT ACCIDENT REPORT
Caribbean Airlines/Fly Jamaica ground collision.

FINAL REPORT

GROUND COLLISION BETWEEN CARIBBEAN AIRLINES BOEING 737-8HO, 9Y-SXM AND FLY JAMAICA BOEING 767-319ER, N767WA AT CHEDDI JAGAN INTERNATIONAL AIRPORT, GEORGETOWN, GUYANA ON 29th NOVEMBER 2016

REPORT No. GAAIU 3/1/12

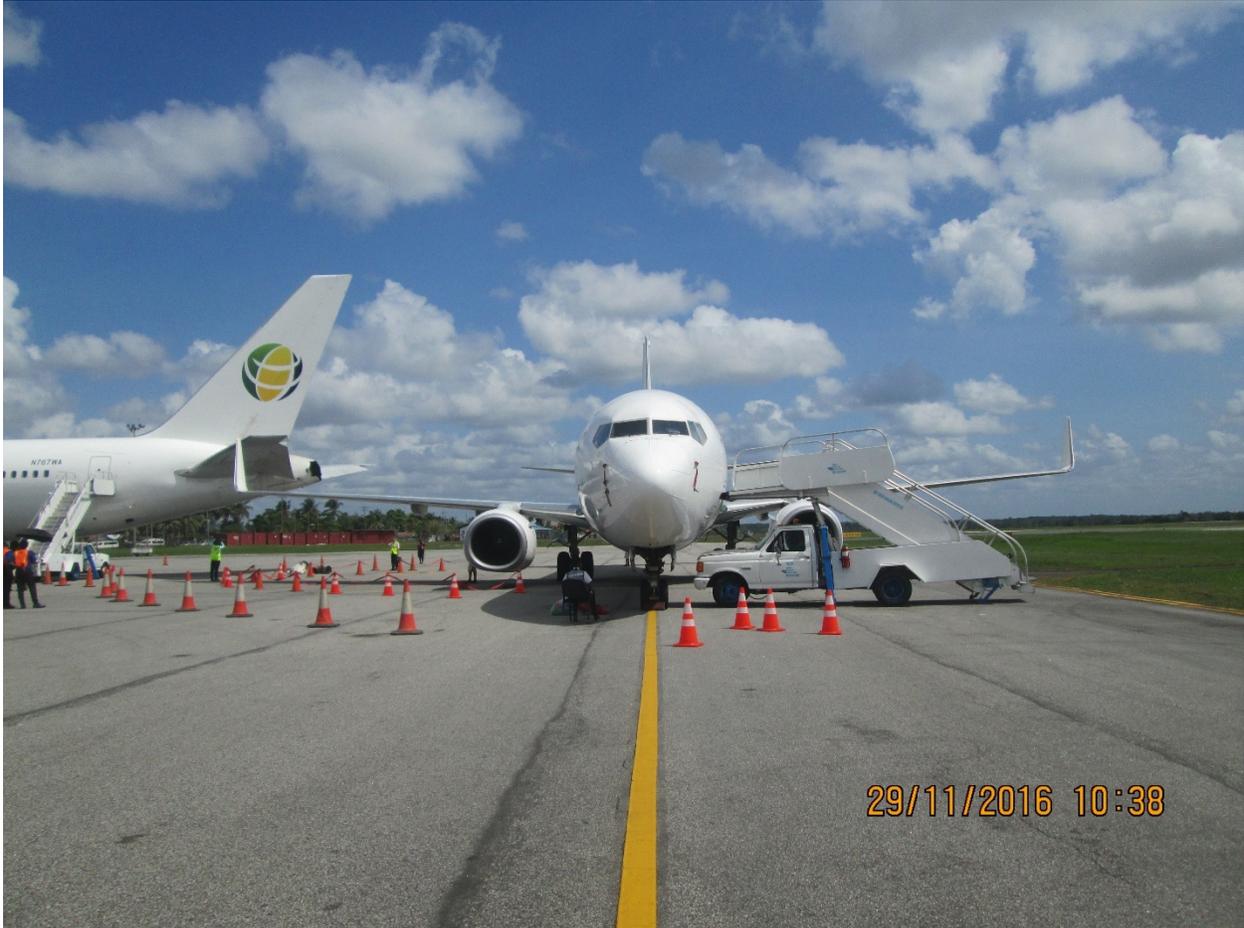
The right winglet of the B737 was damaged by contact with the B767’s elevators and tail cone, to the extent that it had to be replaced.

1. Front view of CAL aircraft.
